## Architectural and historical value - The heritage of the people

**ABSTRACT:** The article addresses the results of staged restoration of architectural and historical monuments of educational building of Kazakh Humanitarian Law Innovative University located at Abay street 94, in Semey city and the current state of other valuable historical monuments with spiritual values and historical significance to future generations of the country.

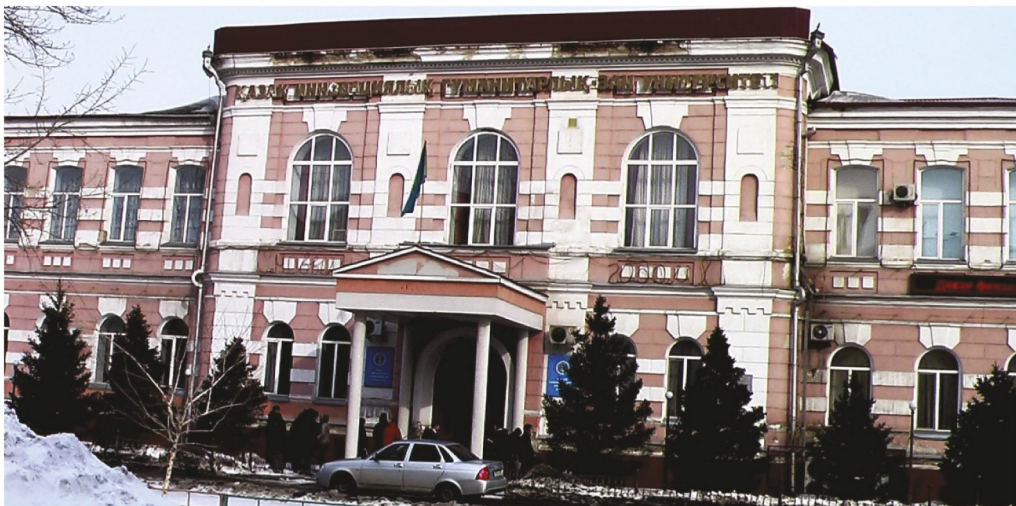
Figure 1. The building of the Kazakh Humanitarian Law Innovative University, before restoration.

The building was built in 1872 and is a national historical and architectural monument. From 1894 to 1919 the building was the educational building of the Pedagogical Institute of the Kazakh SSR (former male gymnasium), from 1919 to 1934 the Siberian district headquarters of the 11th White Guard Regiment. Since 1934 the facility served various educational institutions, and now the building is the educational building of the Kazakh Humanitarian Law Innovative

The general plan of the building is a 2-storey U-shaped house, made in the style of Russian classics, decorated in a component of white and white-pink colors. The length of the main facade, located on the side of Abay Street, is 40,000 mm (40 m) (Fig. External surface of the building is plastered with a traditional lime-sand mortar. Technically, the building consists of three floors - the 1st and 2nd floors and basement. Height of 1st and 2nd floors from floor to ceiling is 3,90 m, basement's - 2,85 m. (its upper side above the ground level of 1.25 m, the lower side of 1.60 m from ground level).

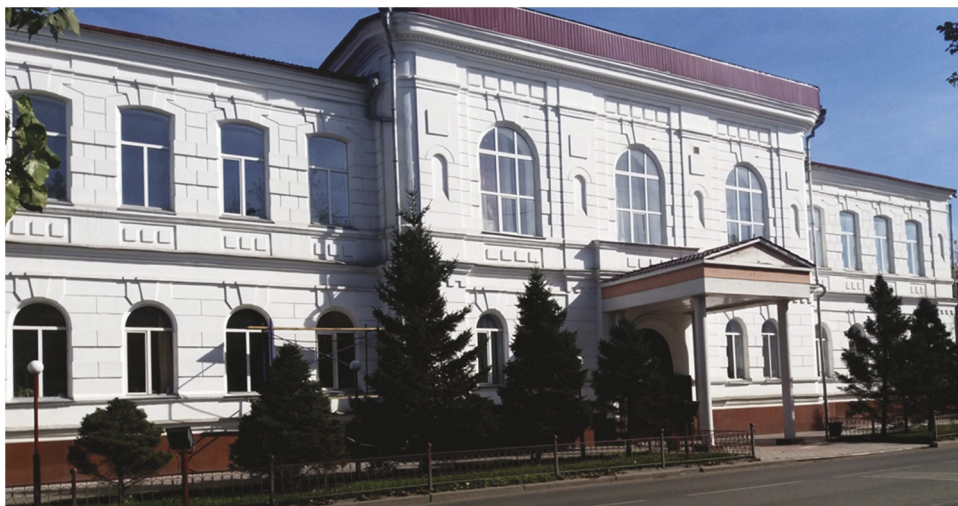
Figure 2. The building of the Kazakh Humanitarian Law Innovative University, after restoration.

Restoration is not an easy task that can be done in a short time, so research work and restoration work go hand in hand here. Because in reconstruction, namely in the modernization of historic buildings, other additional types of work of varying degrees of complexity is involved. Much of the work is done by hand, with great patience and precision, and requires not only professional skill, but also deep knowledge of history and architecture [1,3]. (Figure 2).

As of today, with the support of the university administration, the overhaul and renovation work on the building has been successfully completed on schedule. Before proceeding to such a very important work, we had to step by step and systematically solve many problems. Especially these few concerns had to be addressed:

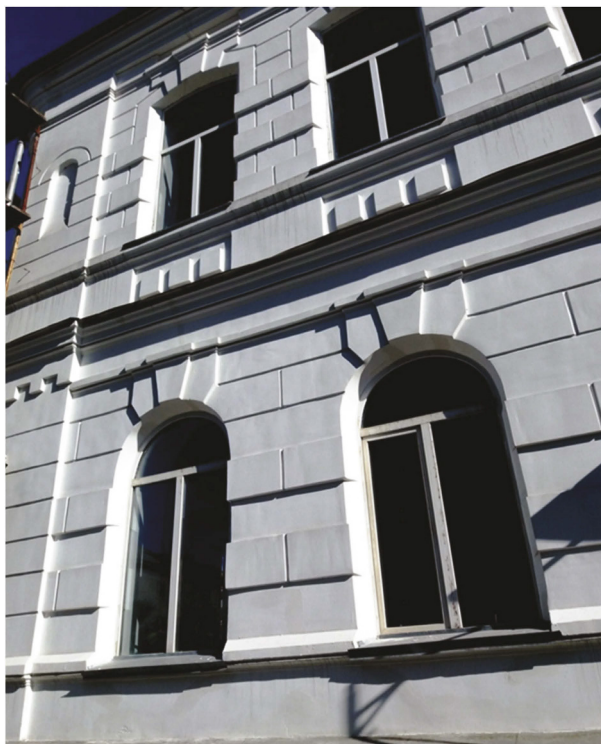
Figure 4. The building of the Kazakh Humanitarian Law Innovative University, after restoration (fragment).

Subsequently, external plaster layers and brick surfaces deemed unsuitable are routinely removed (dismantled) and replaced with new plaster (4,5-drawings);

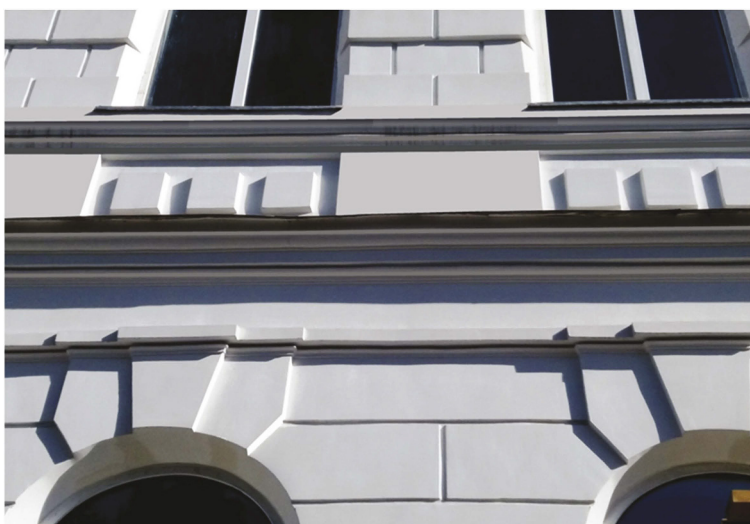
Figure 5. The building of the Kazakh Humanitarian Law Innovative University, after restoration (fragment)

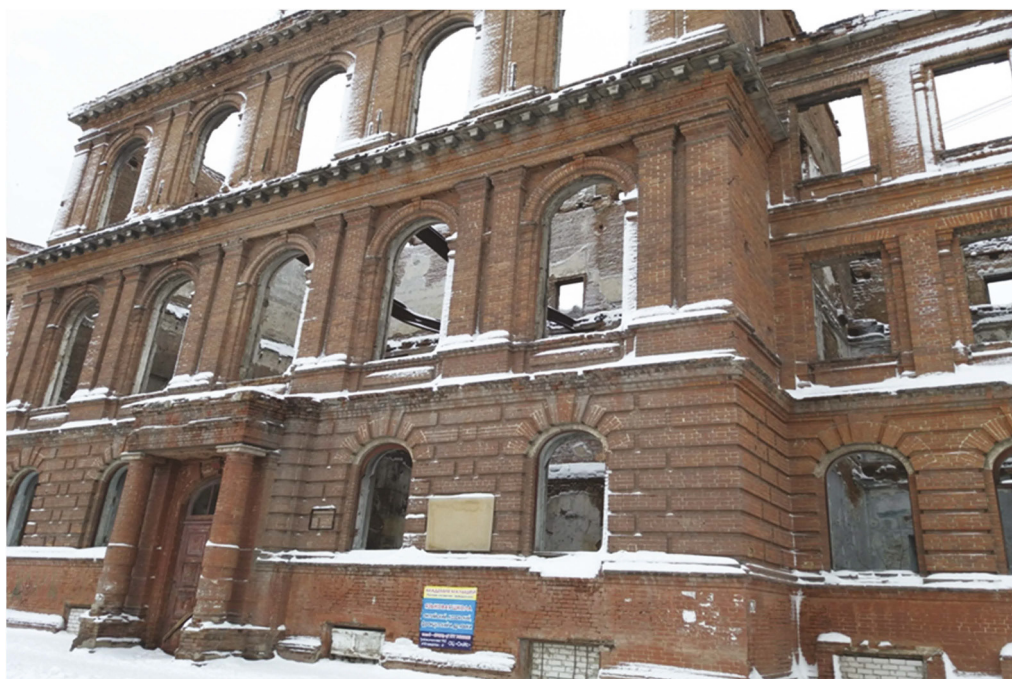
Figure 7. Current view of the former Semey Veterinary Institute building.

The building, built before the revolution (at that time a female gymnasium) burned down for the first time in the assembly hall in the evening of December 10, 1917, and for the second time on December 9, 1986, 69 years later. Since then, 36 years have passed; now the walls of the magnificent building gradually crumble with each year, it is impossible to pass by such a deplorable appearance of buildings without sympathy. (Figure 7).
