Penetration of water into cracked geopolymer mortars by means of neutron radiography

A. El Abd^a, S.E. Kichanov^b, M. Taman^{c,*}, K.M. Nazarov^{b,d}

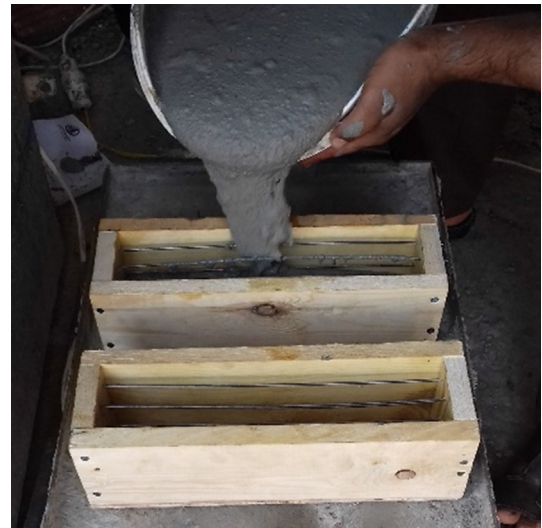
Fig. 1a. Placing of specimens.

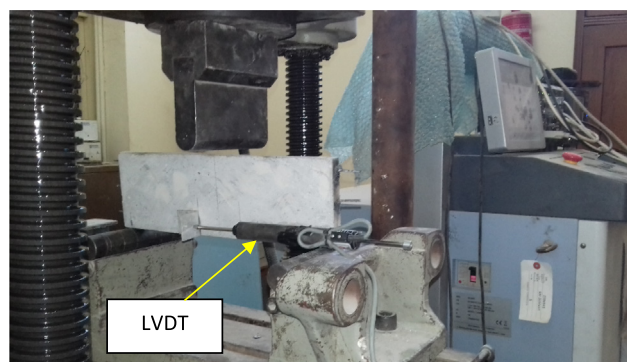
Fig. 1d. Crack creation under three-point loading.
