Case Study Of The Dynamics Of Thermal Expansion Of Concrete In Pavements of South Kazakhstan

Article in *Transportation Engineering* · December 2024

Case study of the dynamics of thermal expansion of concrete in pavements of South Kazakhstan

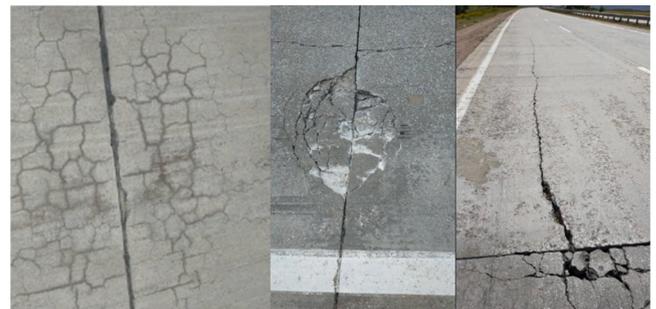
Fig. 3. Dynamics of defect formation in concrete slabs caused by thermal expansion of the 'Shymkent-Taraz' 902 km concrete road (Left: the start of deformations; Middle and right: the end result).

Fig. 3 illustrates the result of concrete slabs "blowing up" or "whipping up" in hot weather at locations of transverse joints that are not wide enough to allow the slabs to expand. The figure shows a section of the Shymkent-Taraz concrete road, where a protective layer of microsurfacing (a mixture of mineral powder and bituminous emulsion) was applied over the concrete. Corrosion occurred at a temperature of 45 °C, with the black colour significantly accelerating the corrosion process.

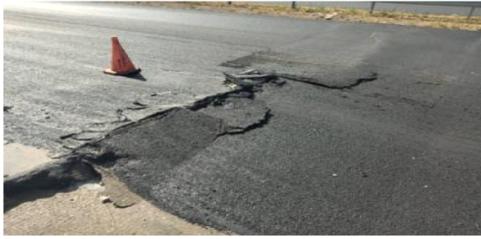
Fig. 4. Warping* of concrete road slabs (blow up)

* A protective layer of bitumen-based microsurfacing was applied to the concrete slab below.

intensively, causing the slab to crack and virtually blow apart (Fig. 4).

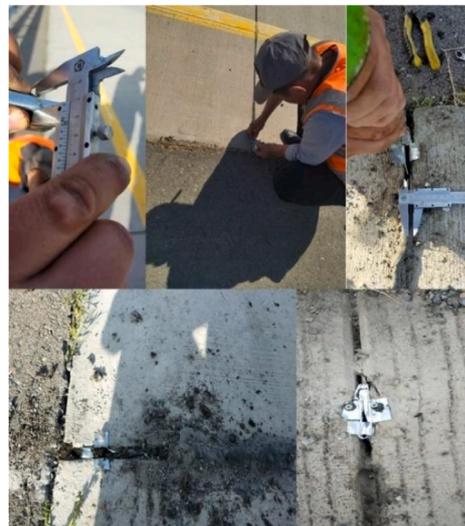
a) installation envelope for mounting, mm

b) Beacon installation process

Fig. 5. Beacons for monitoring the temperature expansion of concrete slabs.

To determine the buckling of concrete roads, a method for monitoring the maximum temperature expansion in joints was established. Beacons were installed on the false and expansion joints in the same plane (Fig. 5).

Beacons were installed at each deformation joint along a 300-meter stretch of the road. The beacons consist of an aluminium tube with a diameter of 16 mm, a wall thickness of 0.8 mm, a length of 40 mm, and an installation envelope, as shown in Fig. 4. The aluminium tube was placed in the envelope, then installed in the deformation joint and fixed to an anchor. A total of 60 beacons were installed.

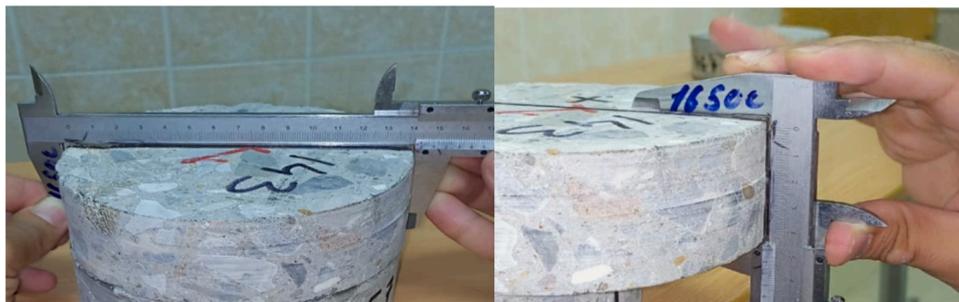
Fig. 6. Measurement of geometric parameters of concrete samples taken from road sections with concrete coating after heating and cooling.

Three concrete core samples were taken from road sections where warping had previously been recorded, indicating that the deformation properties of the concrete depend on temperature. The concrete samples were measured in three directions and placed in a freezing chamber and a drying cabinet (-30 °C and +70 °C). Fig. 6 shows the method used to

measure the geometric parameters of the concrete samples after heating and cooling in two planes.

The results of the measurements of the geometric parameters of concrete samples taken from road sections with cement-concrete pavements, where warping had previously occurred, confirm the dependence of the deformative properties of concrete on temperature. For this, the concrete samples were measured in three directions and placed in both a freezer and a drying cabinet (-30 °C and +70 °C). Fig. 5 shows the method by which the geometric measurements of the concrete samples were made after heating and cooling in two planes.
