Stress State of Modular Blocks with Large Door Openings

Abstract: Modular construction is a modern and efficient type of construction that has gained wide recognition in the construction industry. Limited research has been conducted on how large door openings affect the stress state of modular blocks. The present study aims to investigate the features of the stressed state of modular blocks with large door openings and the effect of size and place of the doors on the openings on the overall structural behavior of the building. Four full-scale (room-sized) modular blocks of the “lying cup” type were tested to failure under vertical loading with eccentricity simulating wind effects. The varied parameters of the specimens included concrete strength and the size of the window openings. Experimental results revealed that crack opening characteristics, main load-bearing wall deformations, horizontal deflections, and failure patterns under vertical loads are directly influenced by the small thickness and increased flexibility of the blocks. The effects of size and the placement of openings on the overall structural behavior of the building were analyzed. Tests revealed the distribution o

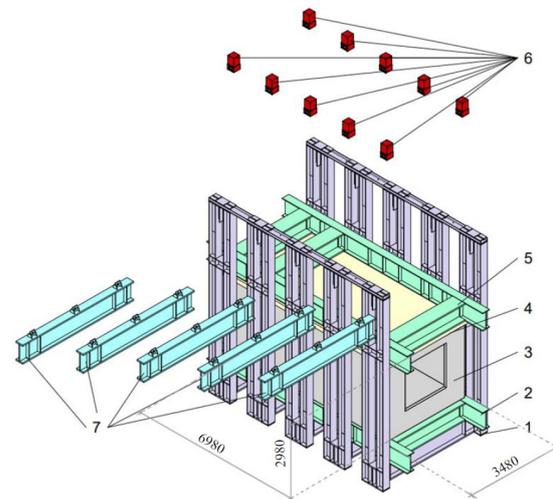
Figure 1. Schematic representation of the test facility with the installed modular block: (1) transverse power frame of the stand (5 pcs); (2) lower steel distribution frame; (3) the test specimen of the modular block; (4) distribution reinforced concrete slab; (5) upper steel distribution frame (lower support of hydraulic jacks); (6) 200 t hydraulic jacks (10 pcs); and (7) upper (lock) beams of power transverse frames (5 pcs.) and upper support of hydraulic jacks.

The testing of four modular blocks was conducted using a custom-designed testing facility. It consisted of a rigid spatial metal frame system with movable bearing elements. The tested modular block was placed on the top beam of the reinforced concrete frame, which incorporated beams supported by the lower beams of the stand. These beams were made of C20/25 concrete and specifically designed to support the weight of modular blocks within a three-dimensional model of a multi-story residential building (Figure 1).

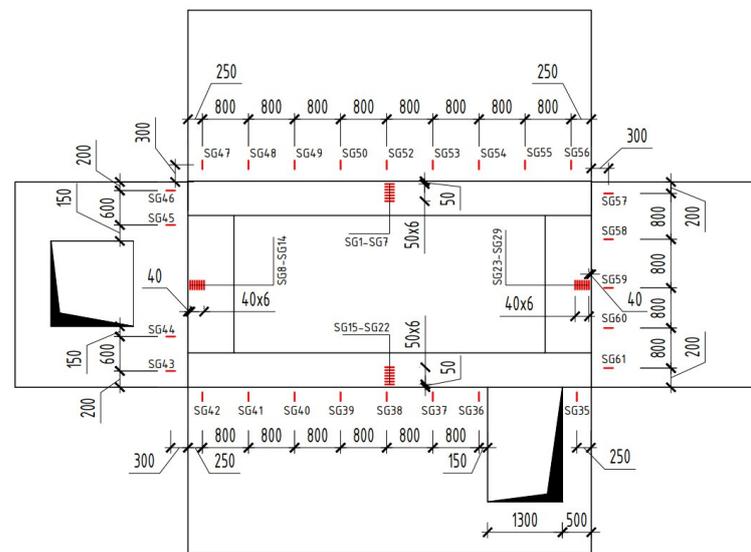
Figure 2. Scheme of the load strain gauge on the walls of the modular block.

Strain gauges with a 50 mm base length and a division value of 10^{-5} were affixed to the concrete surfaces to monitor the strain distribution, complemented by the use of an AID-4M automatic data logger (Figures 2 and 3).

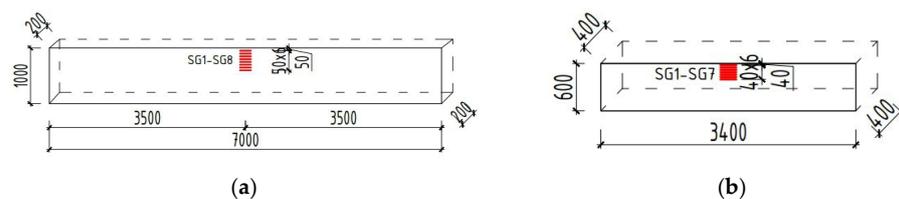
Figure 3. Arrangement of the strain gauge (a) on the longitudinal beams of the stylobate and (b) on the transverse beam of the column support beams.

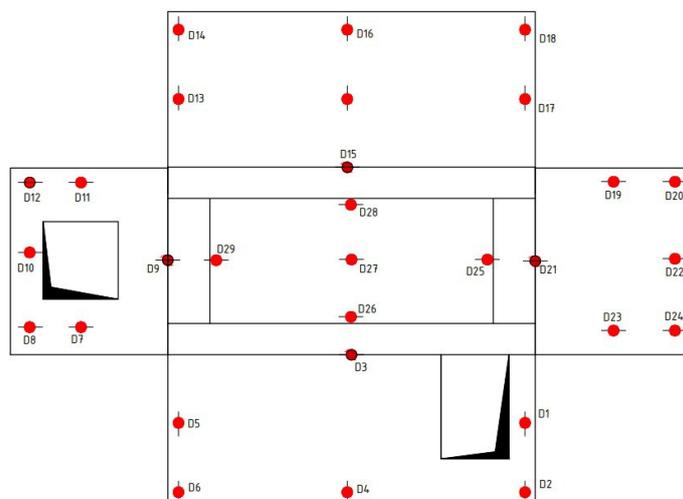
Figure 4. Scheme of the horizontal and vertical arrangement of the deflection indicator.

Horizontal and vertical deflections were recorded using MG-4 and PAO-6 deflection measuring devices with a precision of 0.01 mm (Figure 4). The joint opening between the modular block and column support beams was assessed using PAO-6 deflectors with a resolution of 0.01 m. Additionally, an MPB-3 microscope, with a resolution of $0.02 \mu\text{m}$, was employed to measure crack openings. The loading process was carried out incrementally, with each stage representing 5% to 7% of the anticipated maximum load. The design loads were determined based on the main combination of the design value of actions according to EN for a block with large openings, considering the loads from the upper tiers of standard volumetric blocks made of lightweight expanded clay concrete with a

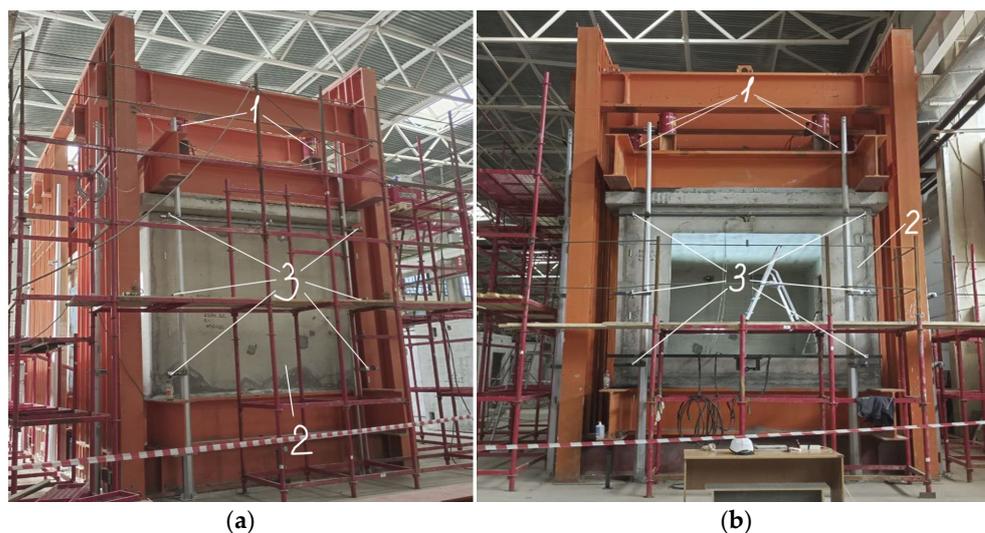
Figure 5. Layout of the tested specimen (a,b): (1) hydraulic jacks; (2) the modular unit under test; and (3) measuring devices.

Figures 5 and 6 present a general view of the modular block test and the loading system section.

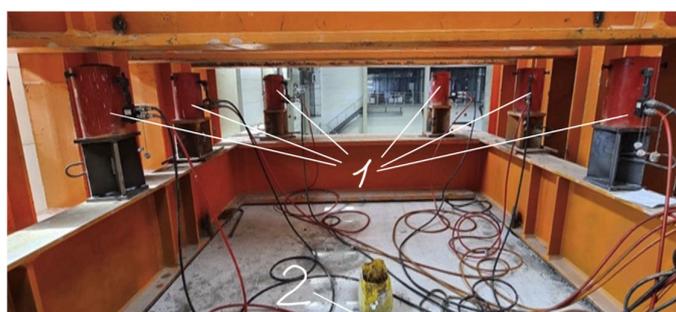
Figure 6. View of the loading system section (hydraulic jacks and beams of the power stand): (1) hydraulic jacks; (2) the modular unit tested.

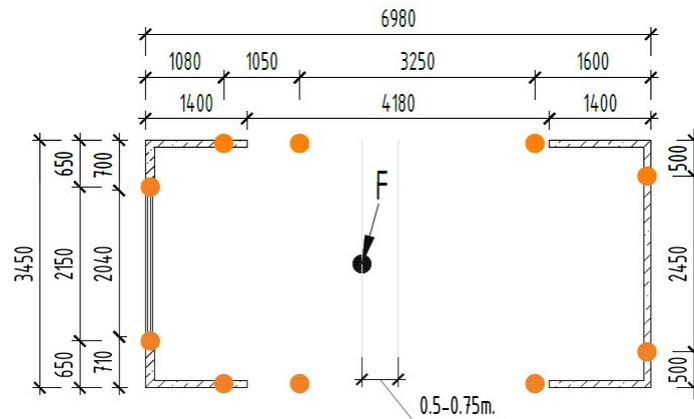
Figure 7. Layout of the hydraulic jack, showing off-center loading of the modular block along the contour.

Figures 7–9 show the setting of hydraulic jacks, strain gauges, and vertical and horizontal deflection measuring devices along the length of the walls to create a longitudinal force eccentricity of 0.75 m, thereby simulating the effects of wind.

The hydraulic jacks were installed in accordance with the setup shown in Figure 7. The locations of load cells on the walls for measuring compressive deformations and installing deflection measuring devices were repeated as for the first specimen. Under a vertical force of $N = 5754$ kN and $N = 6713$ kN, amounting to 67% and 78%, respectively, of the maximum load, inclined cracks were observed in the end wall lintel, and the width of the crack in the floor slab was 0.4–0.5 cm. At a load of 7672 kN, corresponding to 89%, a crack formed in the angular part of the floor plate joint with the main load-bearing wall. Overall, the modular block was characterized by high crack resistance. Even after reaching the maximum load, the width of the transverse cracks in the floor did not exceed 0.6 cm, and the remaining cracks did not exceed 0.05–0.10 cm (Figure 25).

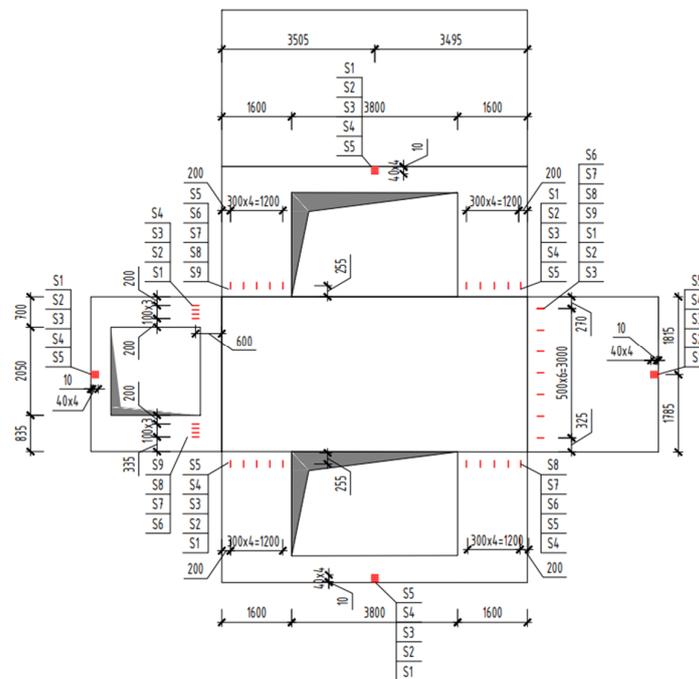
Figure 8. Position of the strain gauges.

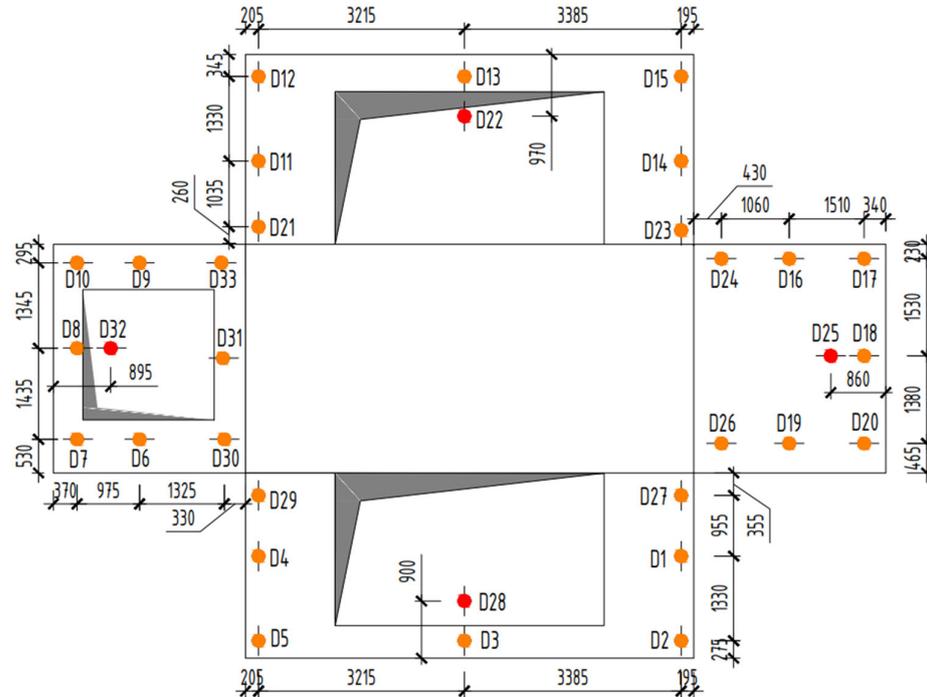
Figure 9. Layout of measuring devices for vertical displacement (red) and horizontal deflections (orange).

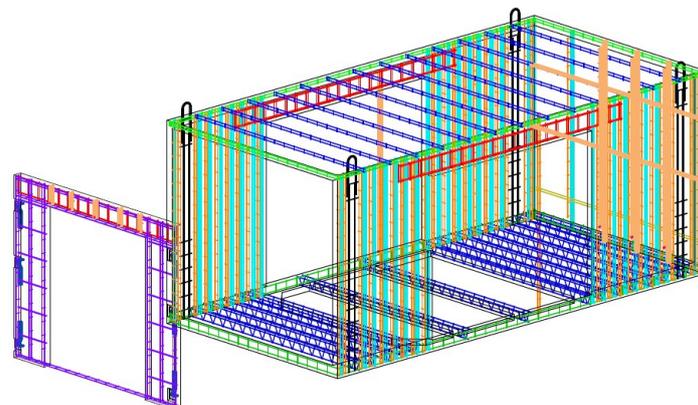
Figure 10. Reinforcement of the longitudinal and transverse walls.

The structural design of the building block is similar to that of lower-tier 9-story modular block structures. It is made from ordinary concrete C30/37. There is an enlarged opening with dimensions of 4180×2400 mm located in each main load-bearing wall, which is 100 mm thick. The end walls are also 100 mm thick and have no openings. The floor slab of the volume block has ribs, with a slab measuring 80 mm and ribs measuring 170 mm. The ceiling panel is flat, with a thickness of 80 mm to 97 mm. Reinforcement for the modular block is provided by spatial frames combined into a single unit (Figure 10).

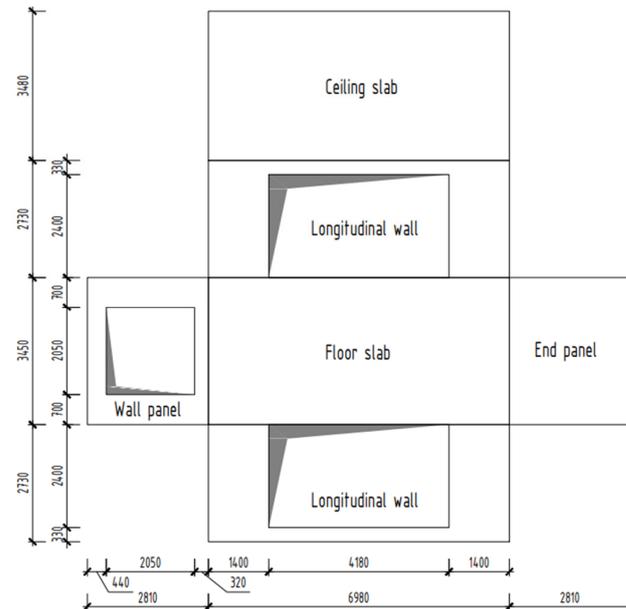
Figure 11. Layout of the modular block.

Separate rods with a ribbed (periodic) profile and class A500 are used. An external (facade) single-layer wall panel is also used, measuring 120 mm, and a frame made from ordinary concrete C30/37 is also used. It has a window opening measuring 2050×2050 mm, as shown in Figure 11.

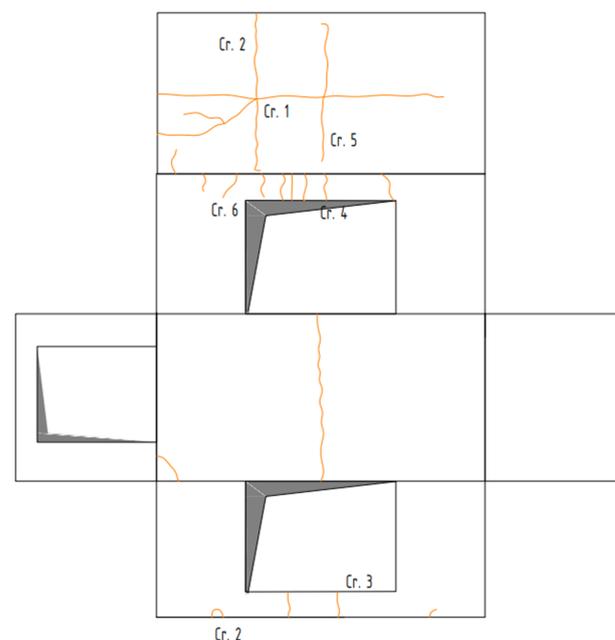
Figure 12. Scheme of the cracks' location during the destruction of a modular block.

The condition of the modular block was monitored during the loading process. Compressive strains, horizontal and vertical deflections, and crack opening widths were measured. Additionally, the general nature of any damage was also assessed, as shown in Figures 12 and 13.

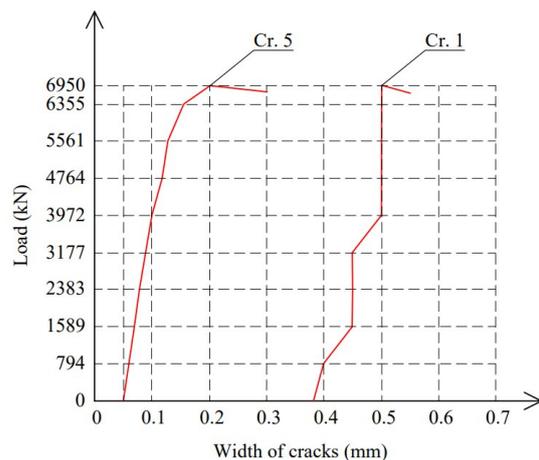
Figure 13. A graph of the development of transverse cracks (red) in the top panels.

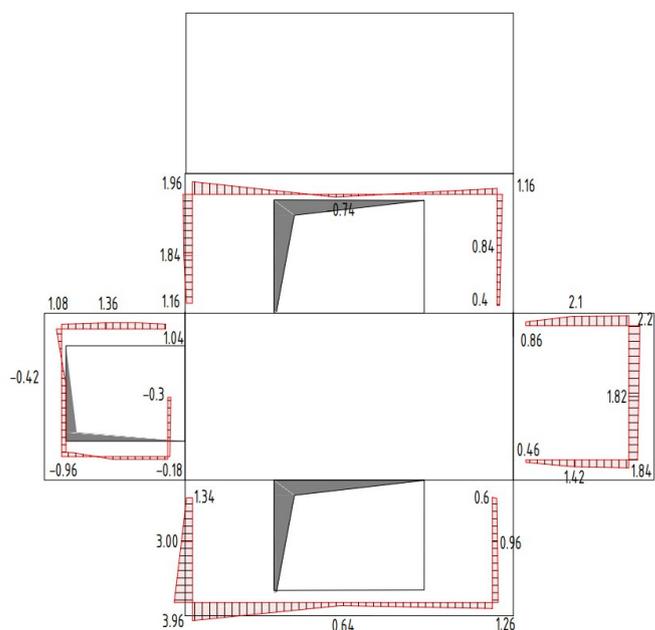
Figure 14. Scheme of horizontal wall deflections, mm in Block No. 1.

Figures 14 and 15 show the diagrams of deflections of the walls from the plane of the modular block.

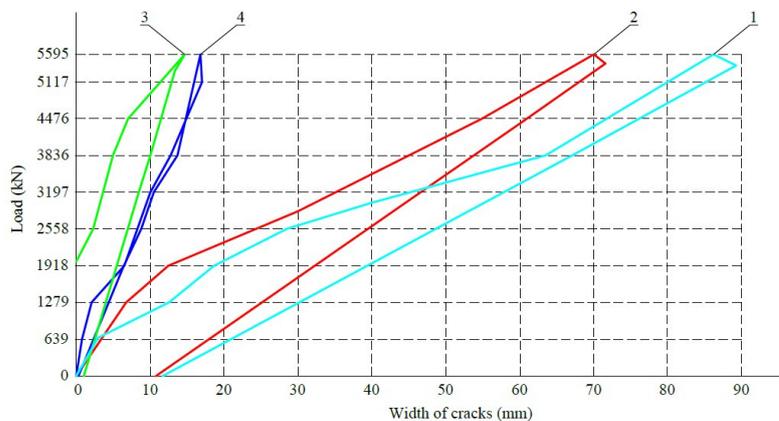
Figure 15. Diagram of horizontal wall deformations: (1, 2) the main load-bearing walls; (3) end wall; and (4) wall panel.

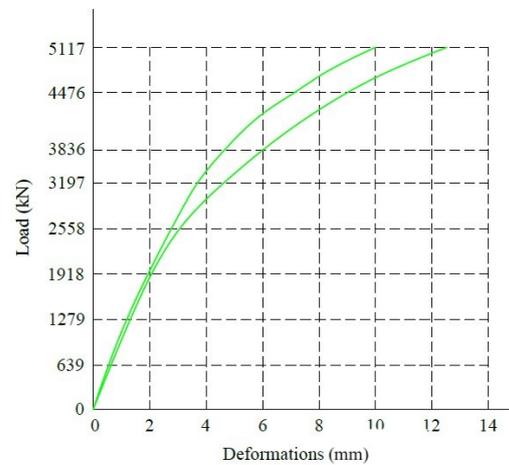
Figure 16. Diagram of strains in the compressed concrete zone of the main load-bearing walls.

Due to the significant force, vertical deflections of the span sections of the main load-bearing walls of the modular block were accompanied by increased concrete compressive strains in the middle part of the spans, as shown in Figure 16.

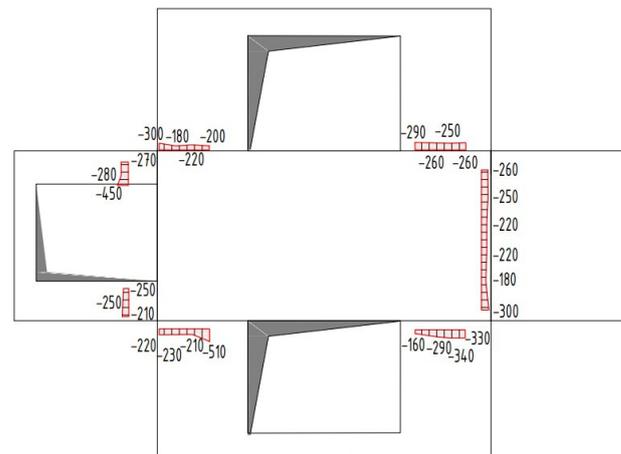
Figure 17. Scheme of concrete compressive strains, 10^{-6} , along the perimeter of the walls under a vertical force of $N = 3197$ kN.

Figures 17–19 illustrate the longitudinal strains of concrete along the perimeter and horizontal deformations of the modular block walls at different vertical force values.

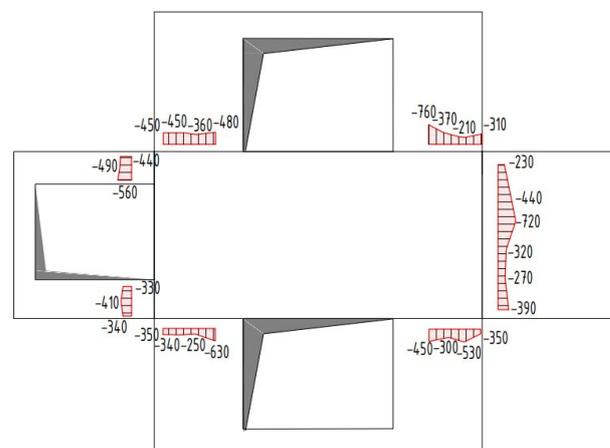
Figure 18. Scheme of concrete compressive strains, 10^{-6} , along the perimeter of the walls under a vertical force of $N = 5114$ kN.

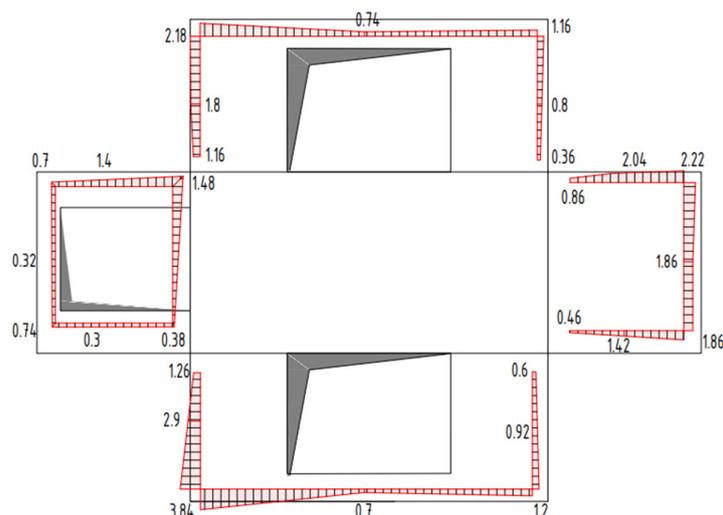
Figure 19. Horizontal deformations, mm, of the modular block walls under a vertical force of 5115 kN.

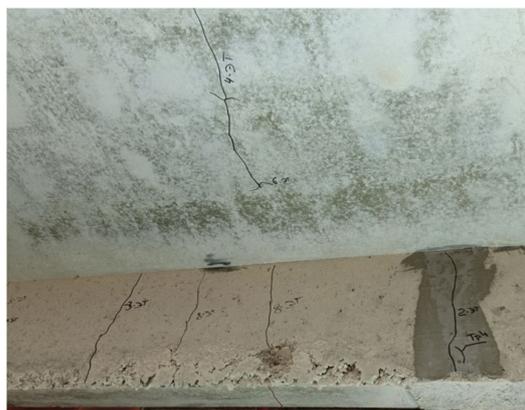
Figure 20. Cracks in the ceiling panel and the lintel in the main load-bearing wall.

The primary damages to the modular block under the maximum load are shown in Figures 20 and 21.

The cause of this type of failure in the thin-walled block with 4.2 m openings in the longitudinal walls was the redistribution of tensile forces to the lintels, ceiling, and floor of the modular block. In practical terms, this led to the necessity of installing additional longitudinal reinforcement in the floor, the effectiveness and sufficiency of which were confirmed during the testing of subsequent specimens.

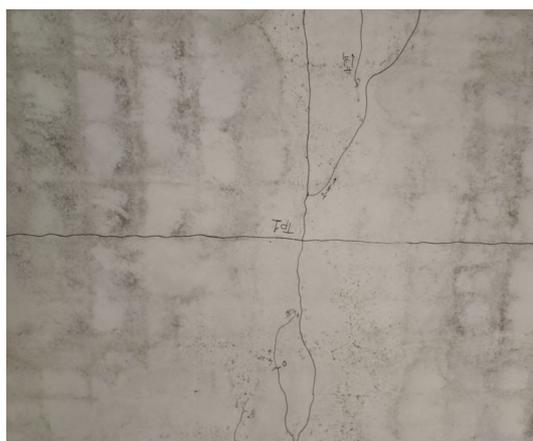
Figure 21. Fragment of the ceiling panel.

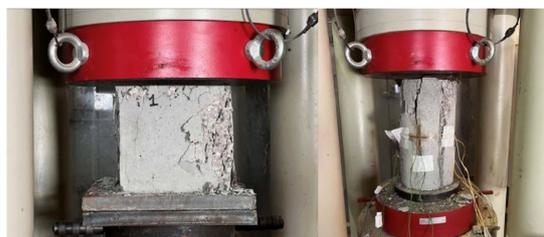
Figure 22. Testing of a concrete cube and a concrete cylinder on an ALPHA 3-3000S hydraulic press.

Prior to the testing of the model, a measurement was conducted to evaluate the strength of the test sample. The measured cube strength of the concrete was 52.9 MPa, with a density of 2300 kg/m^3 , and it had a cylindrical strength of 33.9 MPa. Longitudinal compressive deformations were measured at 11×10^{-4} , while transverse deformations measured 2×10^{-4} (Figures 22 and 23). These samples were made from the same concrete used for molding the block and for monitoring the strength of the modular block.

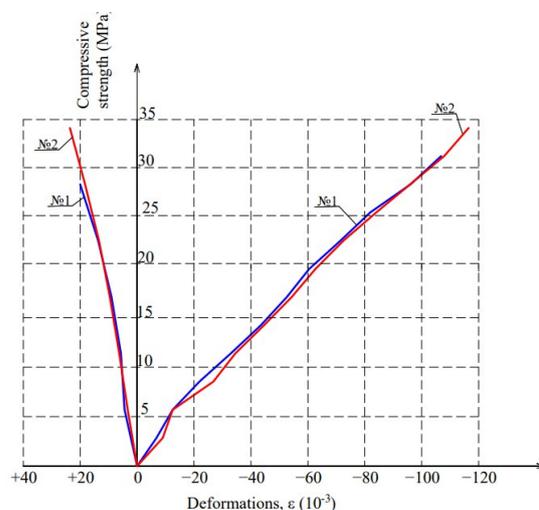
Figure 23. Diagram of longitudinal and transverse strains of concrete cylinders (No. 1, No. 2).

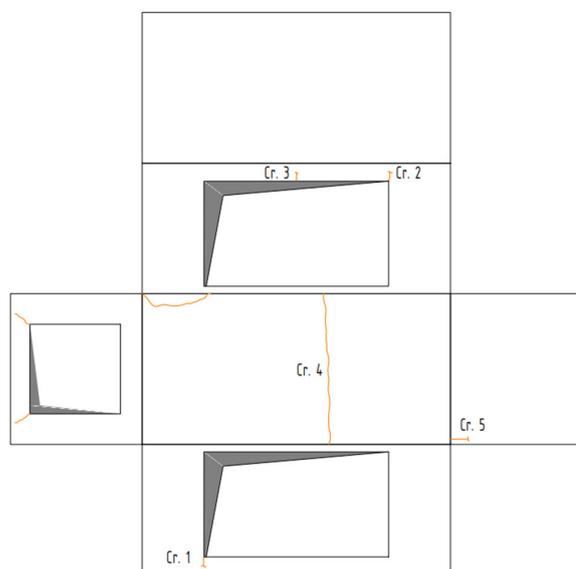
Figure 24. Cracks in the floor plate and lintels of the longitudinal and end walls in Block No. 2.

No significant defects or damage was found in the volume block elements, except for a transverse crack in the floor plate with a width of 0.3 mm and cracks in the lintels of the main load-bearing walls measuring 0.05 mm wide, as demonstrated in Figure 24.

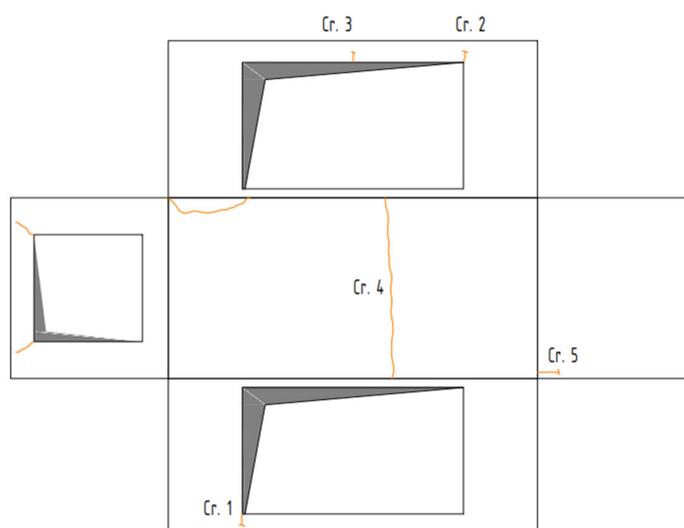
Figure 25. Scheme of the cracks at failure of a modular block.

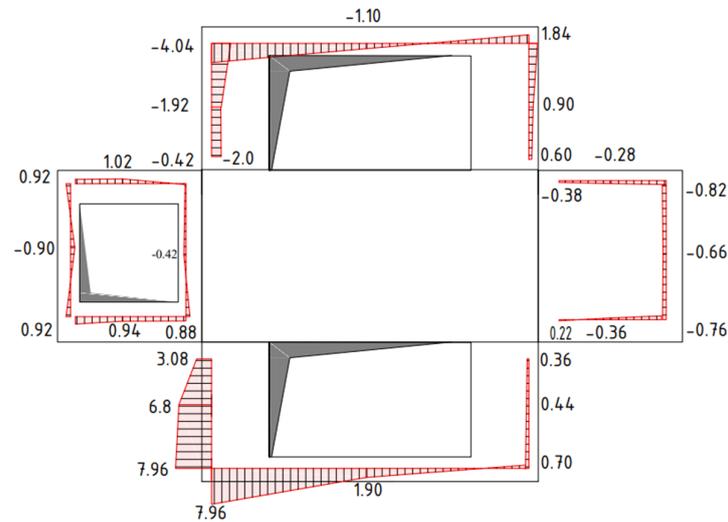
Figure 26. Scheme of horizontal wall deflections, mm in Block No. 2.

of the loss of stability of the main load-bearing walls. This is confirmed by the excessive horizontal deviations of the upper part of the main load-bearing walls, which amount to 4.04 mm and 7.96 mm. The horizontal deflections of the wall panel also amount to 8.3 mm, while the horizontal deviations of the end wall do not exceed 2.0 mm.

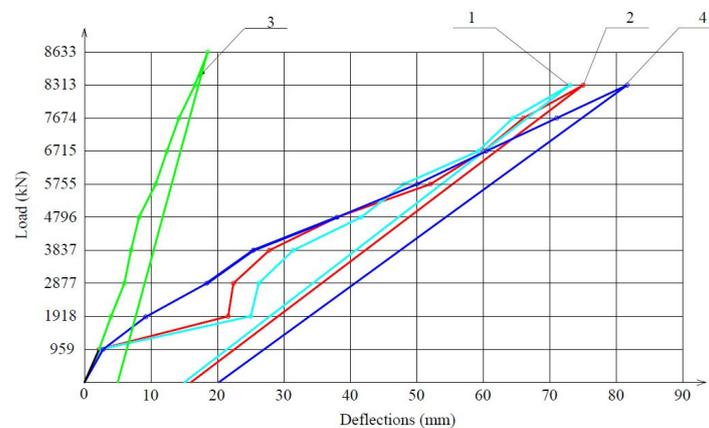
Figure 27. Diagram of horizontal wall deflections in mm: (1, 2) the main load-bearing walls; (3) end wall; and (4) wall panel in Block No. 2.

The vertical deflections of the span sections of the walls in a modular block, under a vertical force of $N = 8311$ kN, was 96% of the maximum load and ranged from 7.3 mm to 7.5 mm for the main load-bearing walls, 1.8 mm for the end wall, and 8.2 mm for the wall panel (Figure 27). The deflections in the end wall were approximately 4.1 to 4.6 times less than those in the main load-bearing walls and the wall panel.

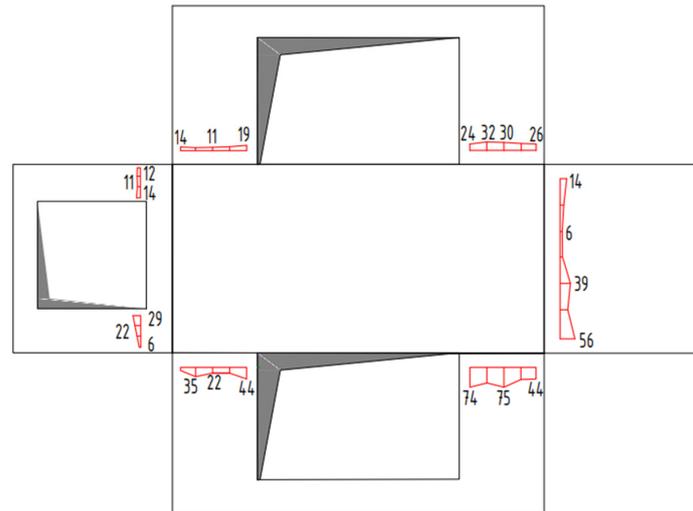
Figure 28. Scheme of concrete compressive strains, 10^{-6} , along the perimeter of walls under a vertical force of $N = 7682 \text{ kN}$.

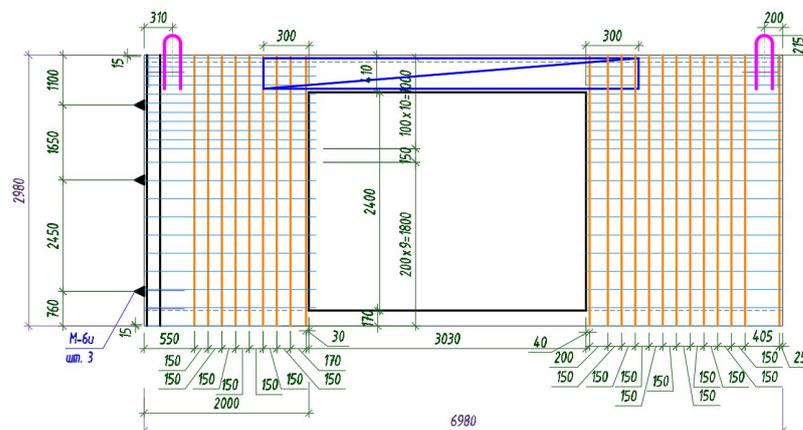
Figure 29. Reinforcement of the main load-bearing wall.

The structural design of the block is based on 16-story, modular building blocks. They are made of ordinary concrete C40/50. Each main load-bearing wall, measuring 100 mm in thickness, has a smaller opening compared to Block No. 2. The opening measures $3000 \times 2400 \text{ mm}$. The end walls, floors, and ceiling panels correspond to the specifications of block No. 1. The modular blocks are reinforced with spatial reinforcement frames, which are thicker than those in blocks No. 1 and No. 2. The exterior, or façade, single-layer load-bearing wall panel in this specimen measures 160 mm thick and is made of heavy C30/40 concrete, with the same window openings as in previous designs in block No. 1. Figure 29 illustrates the geometric and cross-sectional characteristics of the reinforcement.

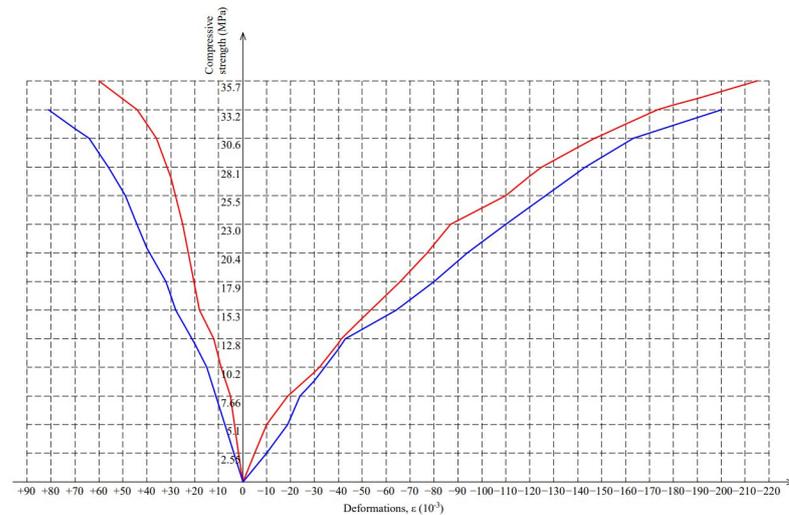
Figure 30. Diagram of longitudinal (red) and transverse (blue) strains of concrete cylinders of a modular block.

The average cubic strength of the concrete in the wall panel was 43.7 MPa, with a cylindrical strength of 31.4 MPa. The maximum longitudinal compression strains of the concrete were 20.6×10^{-4} , and the maximum transverse deformations of the compressed concrete were 7×10^{-4} . The modulus of elasticity of the concrete was 3.0×10^4 MPa (Figures 30 and 31), which indicates that the actual concrete strength corresponds to grade C30/40 (B30). Longitudinal cracks were observed in the ceiling slab, with a crack width of 0.15–0.30 mm.

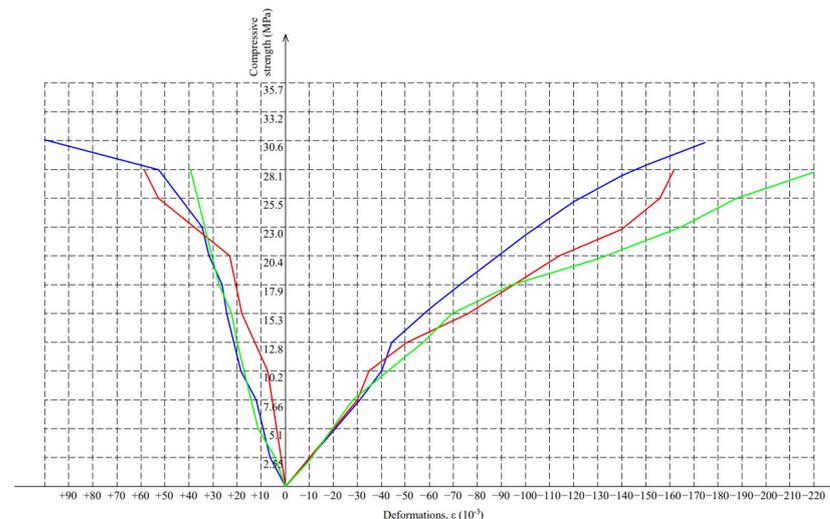
Figure 31. Diagram of longitudinal (blue) and transverse (red, green) strains of concrete cylinders of the wall panel.

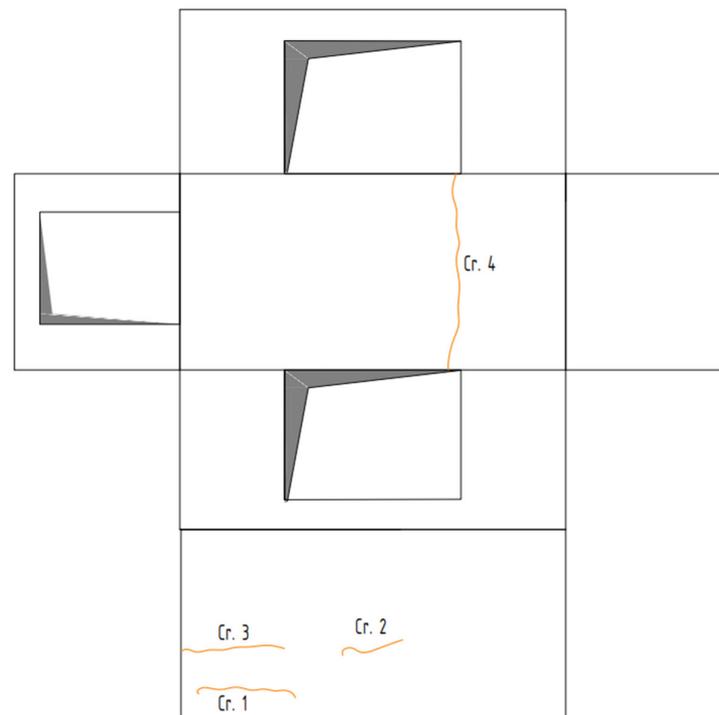
Figure 32. Cracks in the floor plate and lintels of the longitudinal and end walls in Block No. 3.

The examination of the modular block prior to the tests did not reveal any significant defects or damage. However, a transverse crack was detected in the floor slab, with an opening width of 0.25 mm, as illustrated in Figure 32. The sample's behavior is influenced

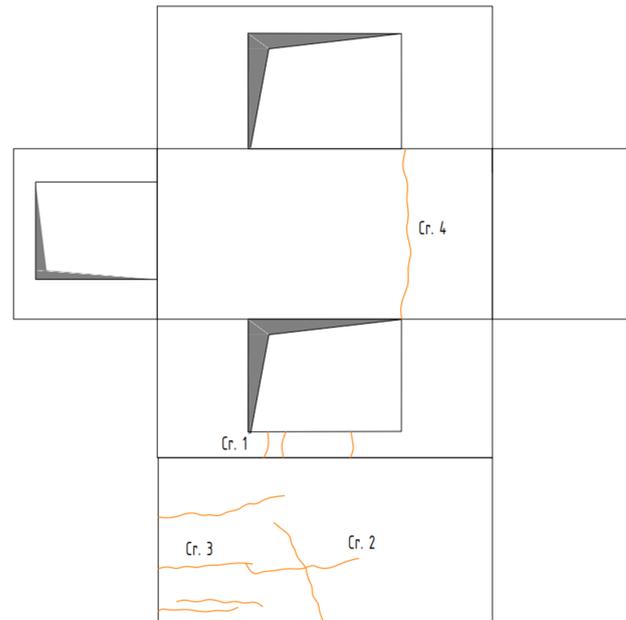
Figure 33. Scheme of cracks under a vertical force of $N = 3835$ kN.

Under a vertical force of $N = 3835$ kN, corresponding to 42% of the maximum load, cracks were observed in the ceiling panel, with a width of 0.15–0.30 cm (Figure 33). At the same time, the concrete strains in the walls were between $(22 \text{ and } 770) \times 10^{-6}$, with an average of 360×10^{-6} . The horizontal deflections of the top of the main load-bearing walls ranged from 0.9 cm to 2.1 cm, and the horizontal deflections of the wall panels were between 0.5 mm and 0.9 mm. The deviations of the end walls ranged from 0.03 mm to 0.4 mm, while multiple cracks developed in the ceiling panel, reaching widths of up to 0.3 cm. Additionally, cracks formed in the lintels of the primary load-bearing walls, measuring between 0.05 cm and 0.2 cm in width, as shown in Figure 33.

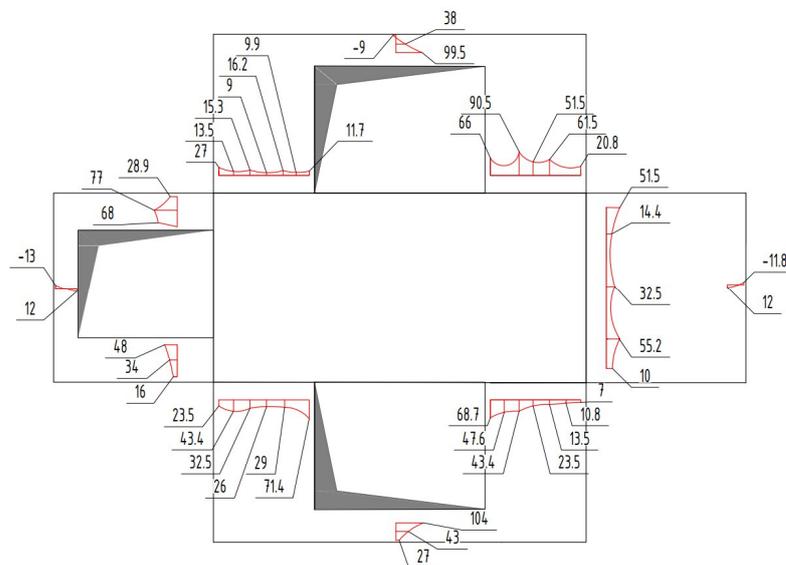
Figure 34. Diagram of concrete compressive strains along the perimeter of the walls under a vertical force of $N = 8631$ kN.

With a load of $N = 8631$ kN applied vertically, which is equivalent to 96% of the maximum capacity, the concrete's longitudinal strains in the walls ranged between $(290$ and $900) \times 10^{-6}$, with an average strain of 570×10^{-6} , as shown in Figure 34. The upper part of the main load-bearing wall experienced horizontal deviations between 3.68 mm and 3.82 mm.

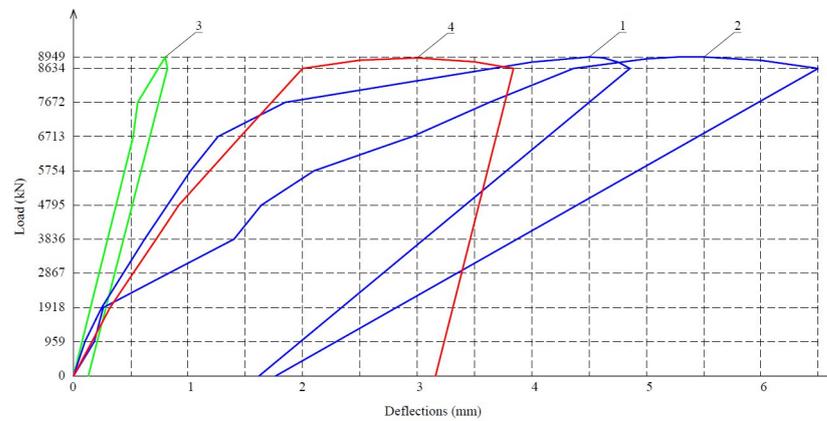
Figure 36. Diagram of horizontal wall deflections in mm: (1, 2) the main load-bearing walls; (3) end wall; and (4) wall panel in Block No. 3.

The vertical deflections of the span sections of the walls of the volume block under a vertical force of 8631 kN, which is 96% of the maximum load, ranged between 7.3 mm and 7.5 mm for the main load-bearing walls, 1.8 mm for the end wall, and 8.2 mm for the wall panel (Figure 37). The vertical deflections of the end wall were about 4.1 to 4.6 times less than those of the main load-bearing wall and the wall panel.

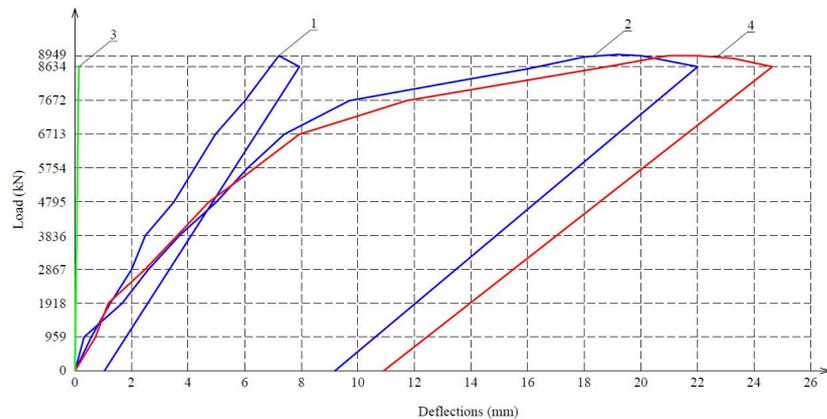
Figure 37. Diagram of vertical deflections in mm: (1, 2) the main load-bearing walls; (3) wall panel; and (4) end wall.

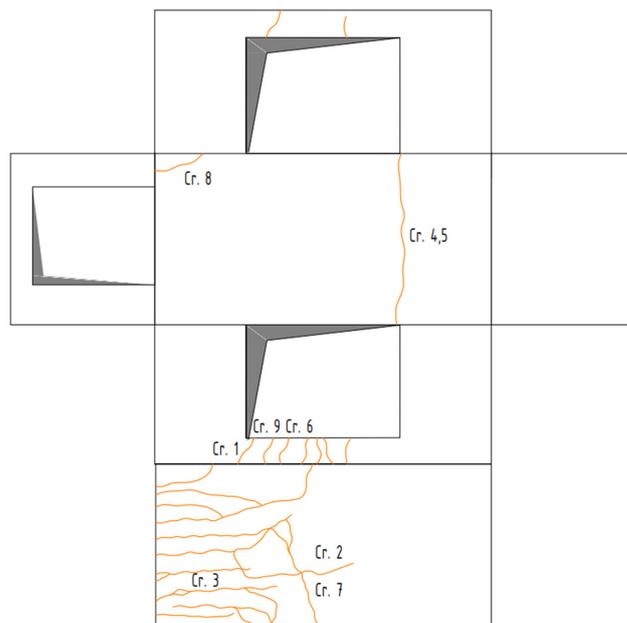
Figure 38. Diagram of cracks under a vertical force of $N = 8631$ kN.

The lintels of the main load-bearing walls, during the initial stages of loading, functioned together with the lower part of the floor slab. As a result, the initial tensile strains in the concrete in the upper part of the lintels increased. However, as the vertical force increased, the lintels started to act as a T-shape structure formed by the floor slab and the lintel. This led to the tensile strains in the upper concrete of the lintels transforming into compressive deformations, reaching 1040×10^{-6} before the modular block failed. At the same time, the crack width in the lintels of the main load-bearing walls reached 0.40 cm, while in the ceiling panels, it extended up to 0.70 cm, as shown in Figure 38.

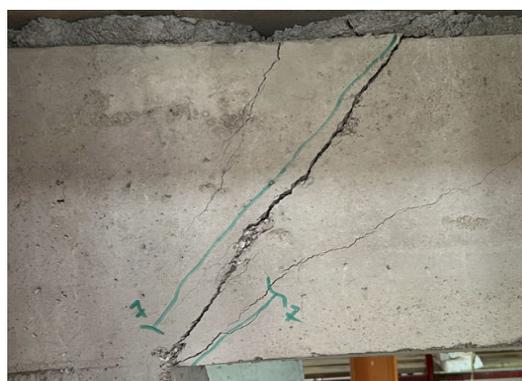
Figure 39. Cracks in the lintel of the main load-bearing wall of the modular block.

The destruction of the modular block occurred under a vertical force of $N = 8949$ kN, leading to the collapse of the lintel and the main load-bearing wall. This was accompanied by a continuous increase in vertical wall deflection, horizontal displacement out of plane, and a significant crack opening. The greatest compressive stresses in the concrete reached 75% in the main load-bearing walls, 50% in the end wall, and 60% in the main load-bearing wall. The damage caused by the maximum load on the modular block is illustrated in Figures 39 and 40.

The specimen's behavior was associated with an increase in the width of the piers in the main load-bearing wall of the module. In these areas (at the corners of the specimen), the primary vertical compressive load from the upper structures was transmitted. As the opening size decreased, the junction of the lintel in the longitudinal wall shifted to a zone of higher tensile forces. This is due to the fact that during testing, to replicate the real behavior of the specimen as part of a multi-story building column, the load on the specimen's ceiling was transmitted through a distribution slab and a mortar joint with a strength of M200–M250. Up to a certain load level, the joint functioned with consideration of adhesion (friction) forces, as the mortar joint does not transfer the tensile force from the overlying structure.

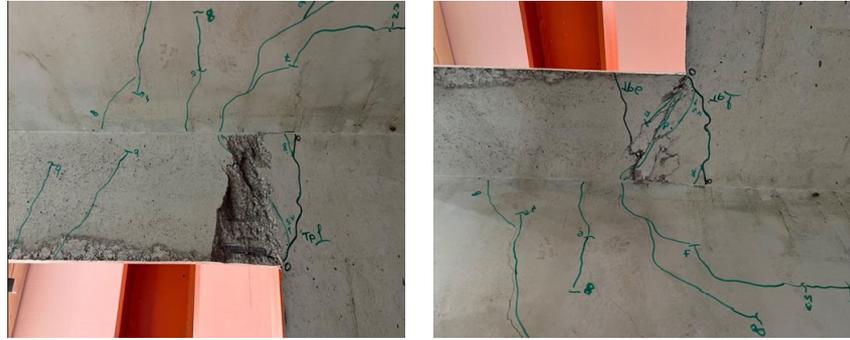
Figure 40. Damage to the lintel of the main load-bearing wall of the modular block.

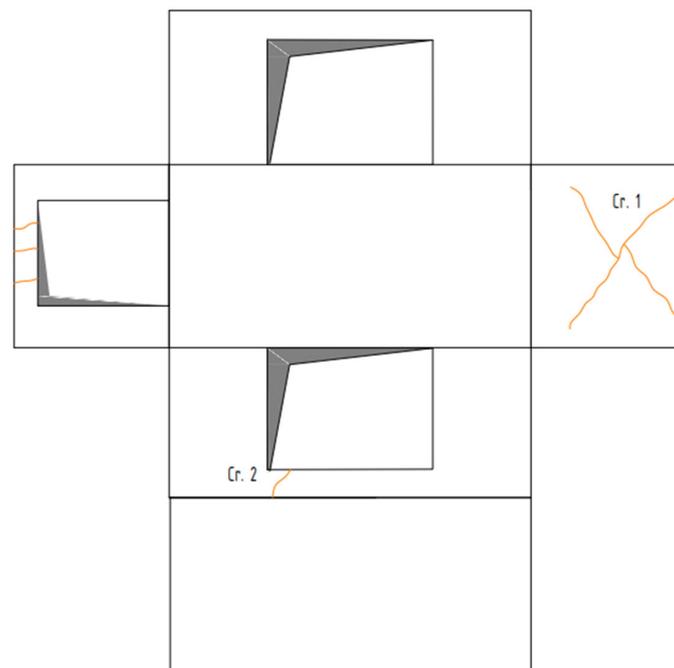
Figure 41. Diagram of the location of cracks under a vertical force of $N = 10,545$ kN.

Under a vertical force of 10,547 kN, the formation of longitudinal and transverse cracks was observed in the ceiling panel. The cracks had an opening width of 0.05 to 0.1 mm. Simultaneously, the longitudinal strains in the concrete in the walls were between $(200 \text{ and } 400) \times 10^{-6}$. Peak strains in the main load-bearing walls ranged from 1130×10^{-6} to 2020×10^{-6} . Horizontal deformations of the upper part of the longitudinal and end walls ranged from 3.34 cm to 4.14 cm, and the horizontal displacement of the wall panel ranged from 0.34 cm to 0.58 cm (Figure 41).

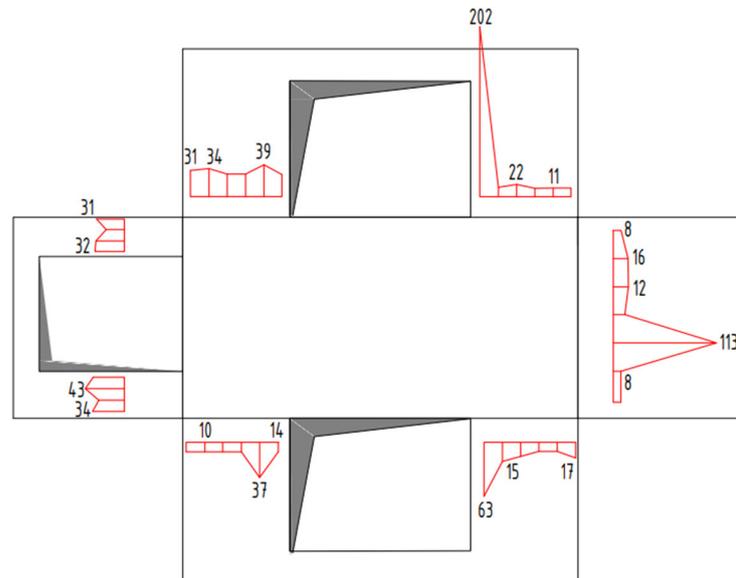
Figure 42. Scheme of compressive strains of concrete along, 10^{-6} , the perimeter of the walls under a vertical force of $N = 12,782$ kN.

Under a vertical force of 12,782 kN, new cracks appeared. The width of the existing cracks remained unchanged, but the longitudinal strains of the concrete in the walls ranged from 58×10^{-6} to 810×10^{-6} , with an average of 420×10^{-6} . The horizontal deviations of the upper part of the walls were between 3.88 cm and 4.94 cm, and the horizontal movements of the wall panels were between 0.52 cm and 1.09 cm. The most significant horizontal deviation of the end wall was 5.76 cm (Figures 42 and 43).

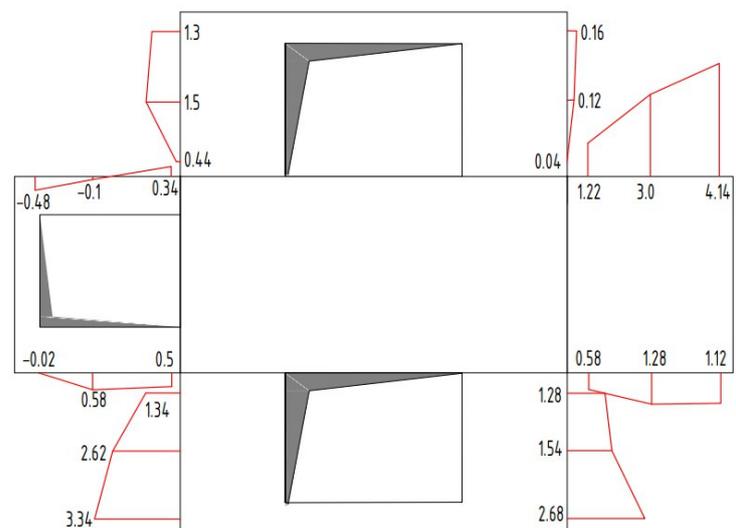
Figure 43. Horizontal wall deflections in mm at a vertical force of $N = 12,782$ kN.

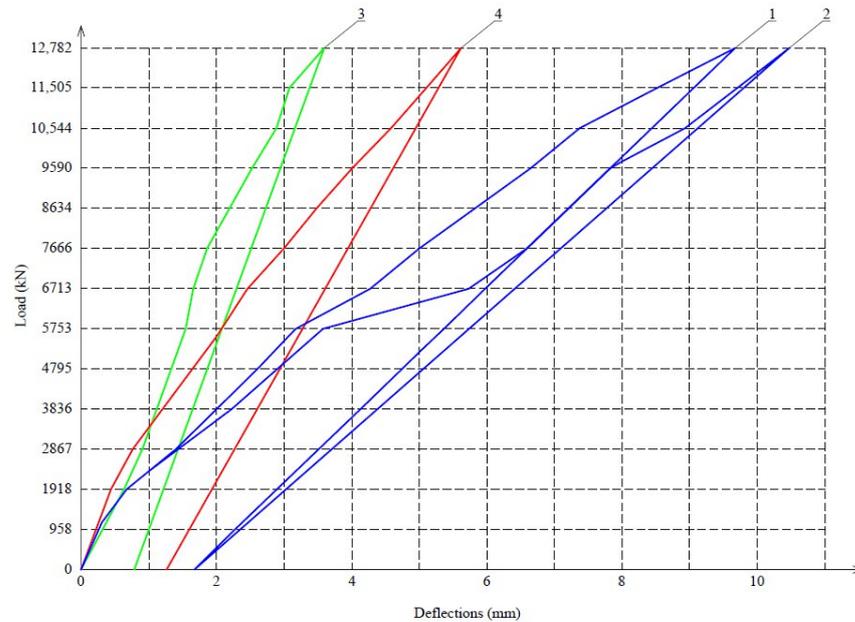
Figure 44. Diagram of horizontal wall deflections under a vertical force of $N = 12,782$ kN: (1, 2) lintel deflections of the main load-bearing walls; (3) deflection of the lintel of the wall panel; and (4) deflections of the end wall.

The vertical deflections of the wall lintels and the end wall of the modular block under a vertical force of $N = 1304.33$ kN were 9.18 and 10.4 mm, respectively, in the main load-bearing walls, 3.58 mm in the end wall, and 5.68 mm in the wall panel, considering the deflection meter readings at zero pressure in the system after the failure load (Figure 44).

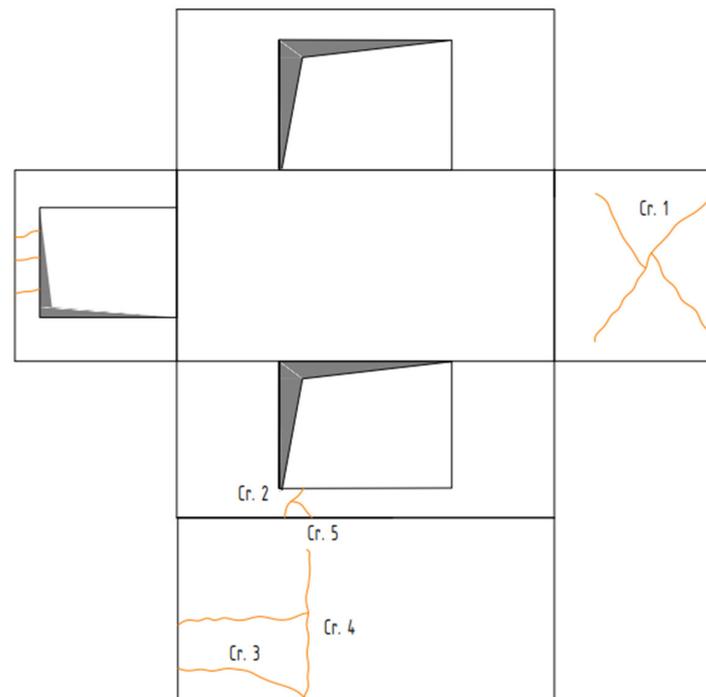
Figure 45. Diagram of the location of cracks under a vertical force of $N = 12,782$ kN.

The cracks width in the lintels of the main load-bearing walls were 0.05–0.10 mm, and in the ceiling panel, they were 0.10–0.20 mm, while in the end wall, they were 0.1 mm, taking into account the readings of the deflection meters at zero pressure in the system after the failure load (Figure 45).

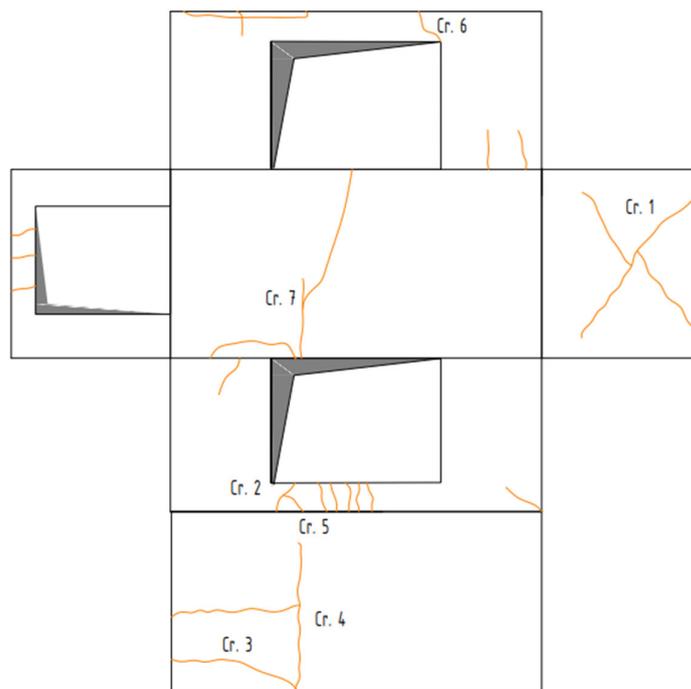
Figure 46. Crack pattern under the maximum load.

After applying a vertical force of $N = 12,782$ kN, the tests were paused and continued after 35 days. During this time, the strain on the concrete in the elements of the modular block increased by an average of 2%. A further increase in the vertical force did not cause an increase in the width of existing cracks, except for a transverse crack in the floor plate and ceiling panel, where the crack width reached 1.30 cm and 0.55 cm, respectively. The destruction of the modular block failed at the load of $N = 16,620$ kN, followed by a continuous widening of transverse cracks that led to the separation of the panels (Figure 46).

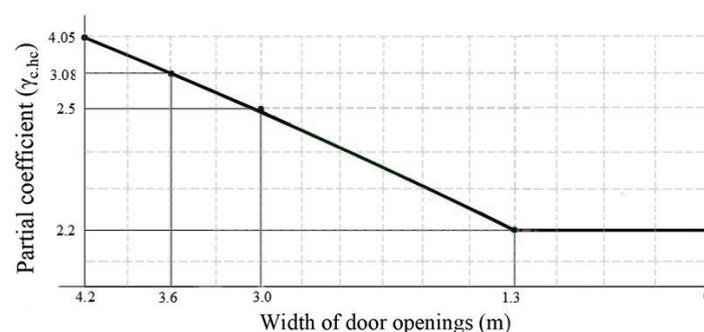
Figure 47. Dependence of the modular block performance ratio on the width of door openings.

The results of the studies presented in this article allow for determining the value of the partial behavior coefficient of modular blocks with increased door opening widths under vertical force, which was caused by the increased flexibility of load-bearing walls, using the formula:
