Multi-Story Volumetric Blocks Buildings with Lower Frame Floors

Abstract: This article presents the results of experimental studies of the stress–strain state of volumetric blocks based on the underlying frame structures. The aim of the research is to evaluate the stress–strain state and the nature of damage development as a result of an increase in the load up to a critical level. Based on the analysis of the nature of the damage, recommendations have been developed to strengthen the destruction zone. Data were collected on the redistribution of stresses and deformations, the formation of cracks and joint openings, the magnitude of horizontal displacements, and the failure mode of volumetric blocks and floor frames. Five full-scale volumetric blocks were tested under the loading of hydraulic jacks, differing in concrete type, reinforcement, presence of doors, and dimensions of the stylobate beams. When the volumetric modules were supported by a frame floor the results revealed that the maximum destructive load of 10,462 kN was observed in the first specimen; the horizontal displacements of the walls decreased by 13–18 mm, and there was a decrease in the crack opening width to 0.5

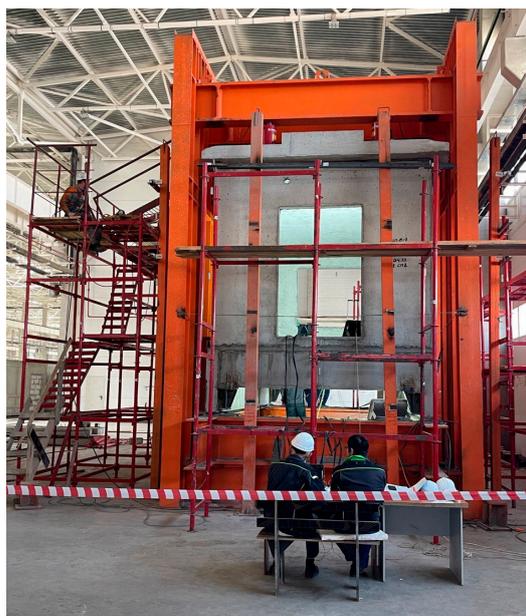
Figure 6. General view of the volumetric block tests.

of 10^{-6} , and data from them were recorded on the strain gauge equipment. Horizontal displacements (deplanation of the volumetric blocks) and vertical deflections of the beams were also measured using a digital deflection indicator. The deflection indicator was mounted on 12 racks independently disconnected to the stand, with 3 deflection indicators on each rack. They were mounted on tripods beneath the horizontal beam structures. The opening width of the layers between the volumetric block and the stylobate beams was measured using PAO-6 deflectors with a division value of 0.01 mm [22]. The crack openings were measured with an MPB-3 microscope with a division value of 0.02 mm as seen in Figure 6.

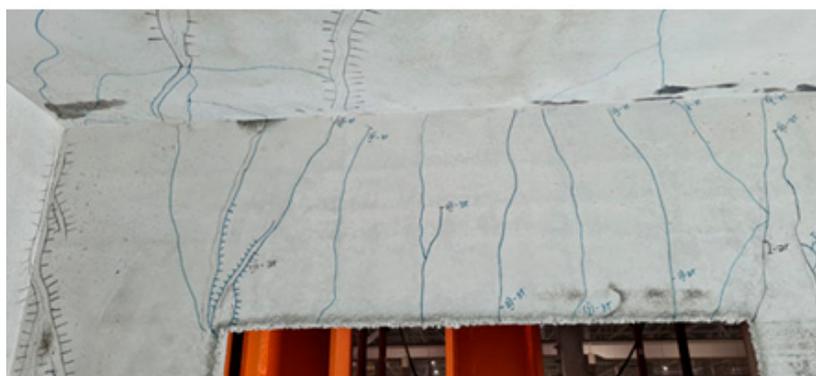
Figure 22. Damage to the lintel above the doorway of the longitudinal wall doorway.

The failure of the volumetric block occurred under a vertical load of $N = 5754$ kN and was accompanied by a split of the angular part of the lintel at the entrance of the longitudinal wall under a vertical change in the crack banks, and a crack opening of 1.5–2.0 mm is shown in Figure 22. The highest compressive strains in concrete in the extreme parts of the continuous longitudinal wall were in the range of $(600\text{--}620) \times 10^{-6}$, while in the middle part of the wall, they were 370×10^{-6} . The maximum compressive strains in concrete in the extreme parts of the longitudinal wall with a doorway were in the range of $(630\text{--}770) \times 10^{-6}$ and in the middle part of the wall 390×10^{-6} . The maximum compression strains in the concrete of the end wall and panel were $(360\text{--}370) \times 10^{-6}$.

A vertical and inclined crack system with an opening width of 0.20–0.25 mm was formed on the entire surface of the lintel above the doorway. New vertical cracks appeared in the longitudinal walls and the crack in the solid longitudinal wall increased from 0.8 mm to 1.0 mm. New longitudinal cracks have formed on the ceiling slab, as well as transverse cracks on the floor slab. The width of the gap opening between the floor slab of the volumetric block and the longitudinal reinforced concrete beam on the stylobate increased to 2.0 mm.

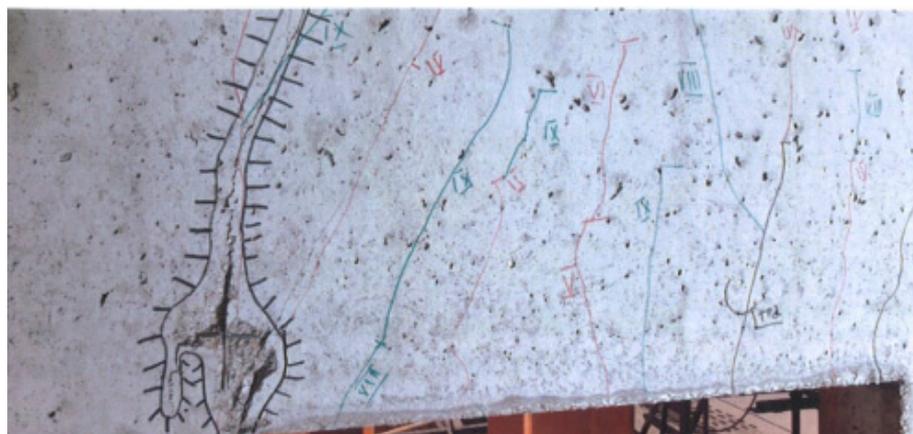
Figure 25. Failure of the longitudinal wall lintel with a change in the crack banks.

Under a vertical load of $N = 7973$ kN (90% of the destructive load), a grid of longitudinal cracks was formed on the ceiling and floor slabs, inclined cracks in a solid wall, and vertical cracks in the lintels of the longitudinal end wall. Figure 25 shows the volumetric block failed under a vertical load of $N = 8863$ kN due to the splitting of the longitudinal wall lintel and a vertical shift of the crack banks.
